Blackwood Creek Project Implementation

*Geomorphic form restoration—Providing
the foundation to restore riparian
vegetation structure,
habitats, and aquatic life*

Craig Oehrli – Hydrologist
Lake Tahoe Basin Mgt Unit
Forest Service

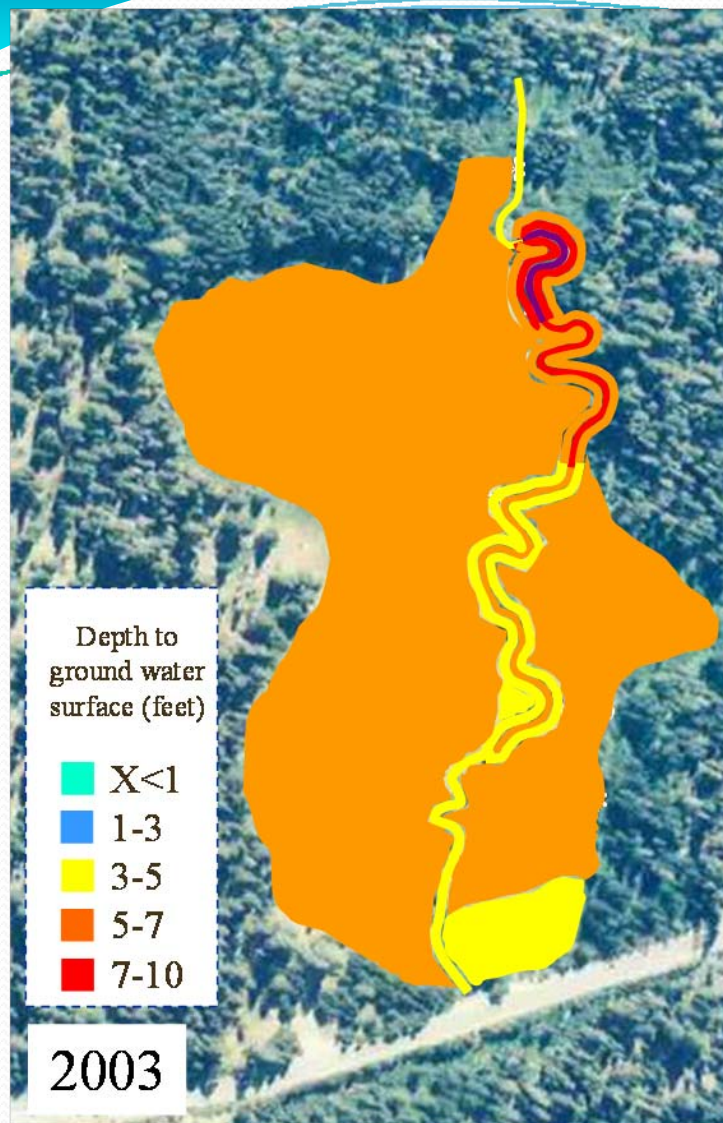
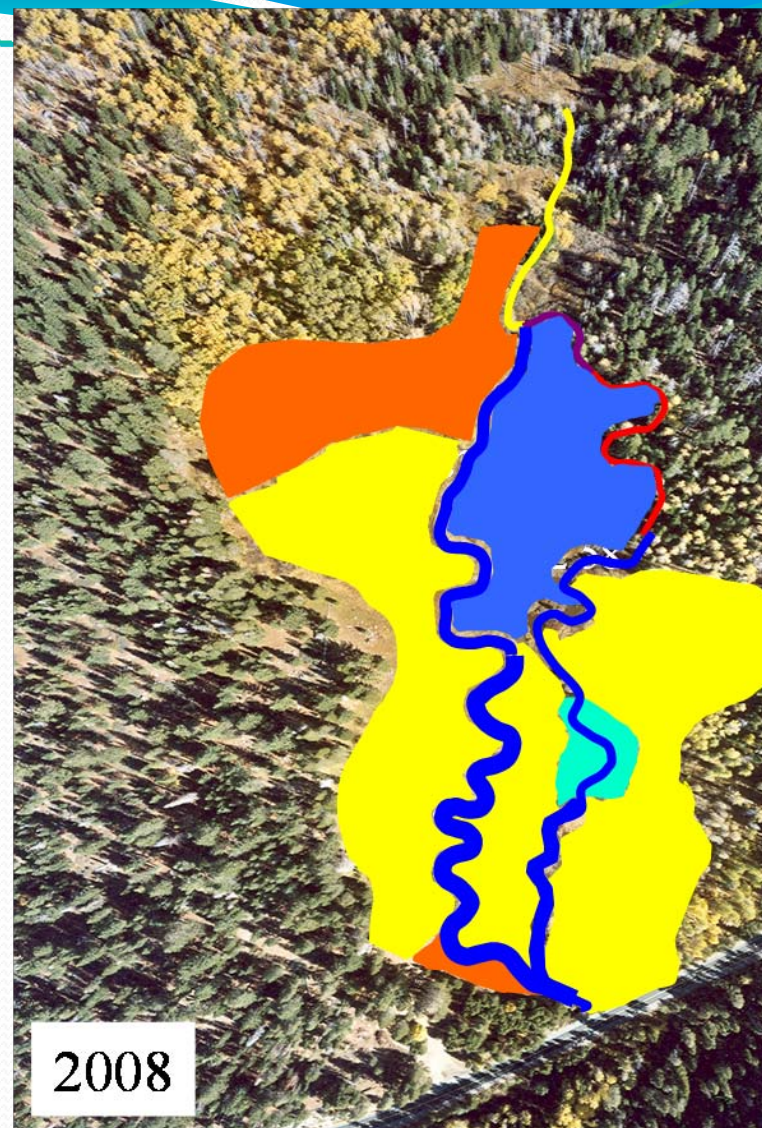
Result: Increased wetted area with available water for plants during the late summer is estimated to have increased 10% in 2007 and 60% in 2008.

Late Summer ground water levels in Cookhouse Meadow

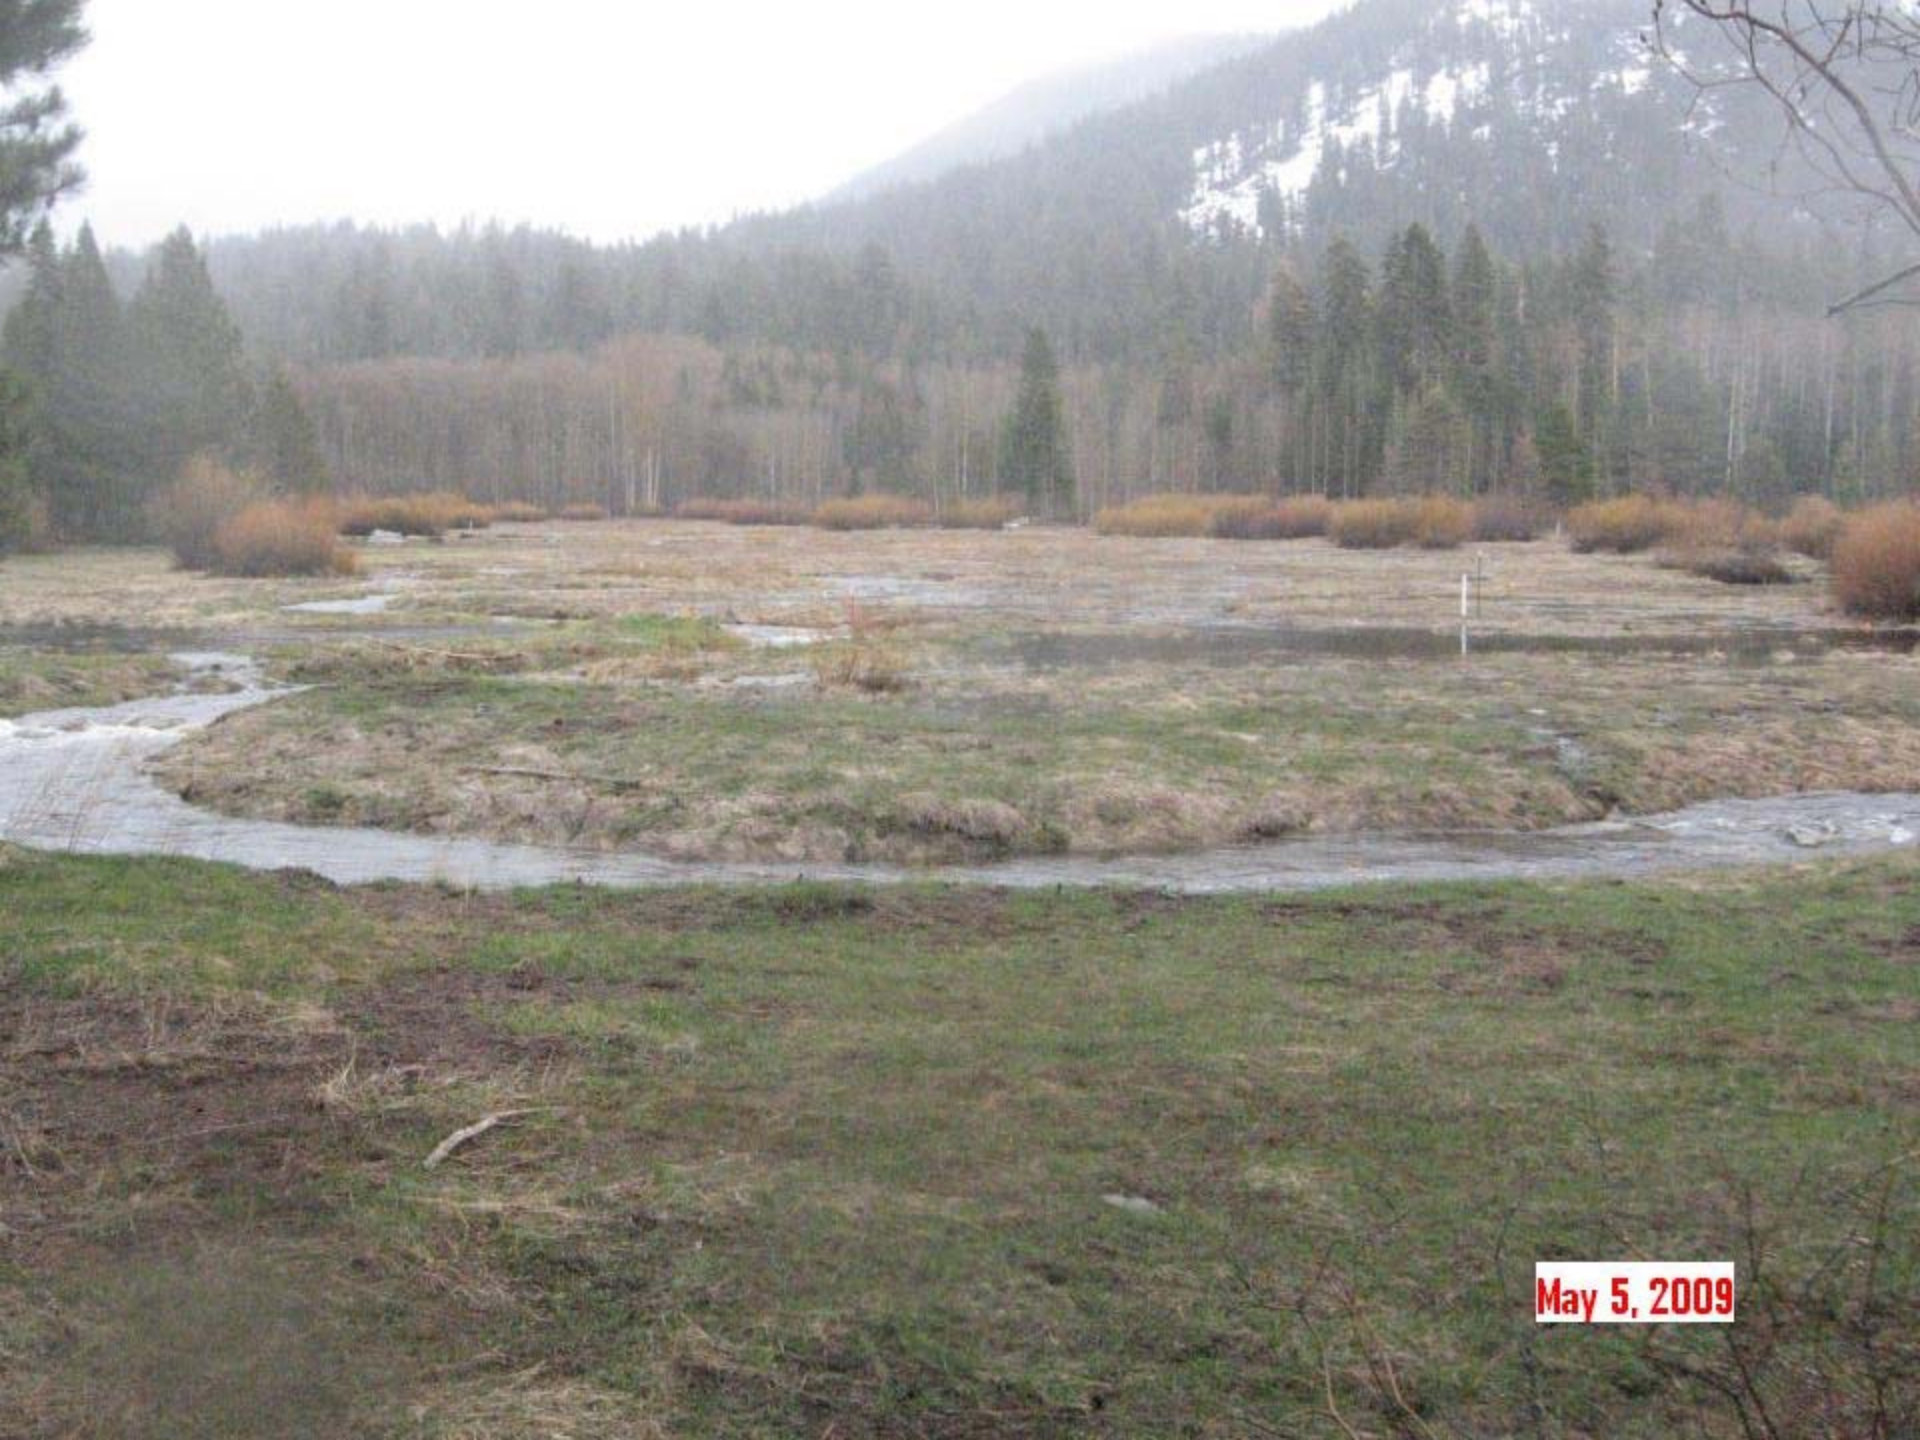
May 5, 2009

Result: Approximately 10% of channel went overbank for 6 days in 2008, approximately 50% of the meadow during a 21 day period following rain on snow events in May of 2009. Over bank flooding during the spring of 2009 was observed to have resulted in the deposition of fine sediments and organic detritus throughout the floodplain.

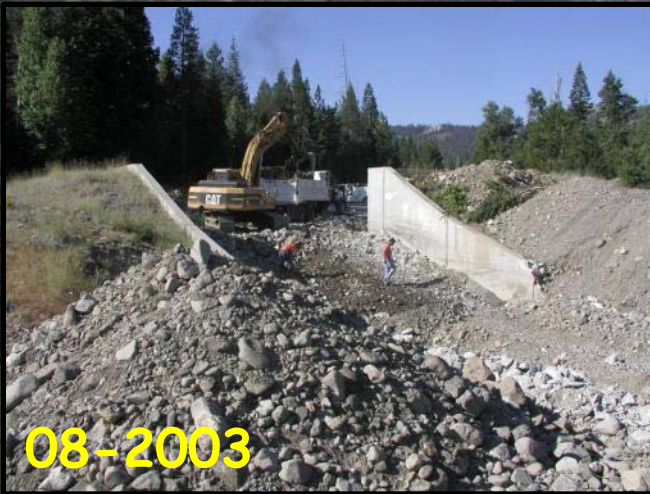
Likely fish migration impairment (LWQCB, 2007)

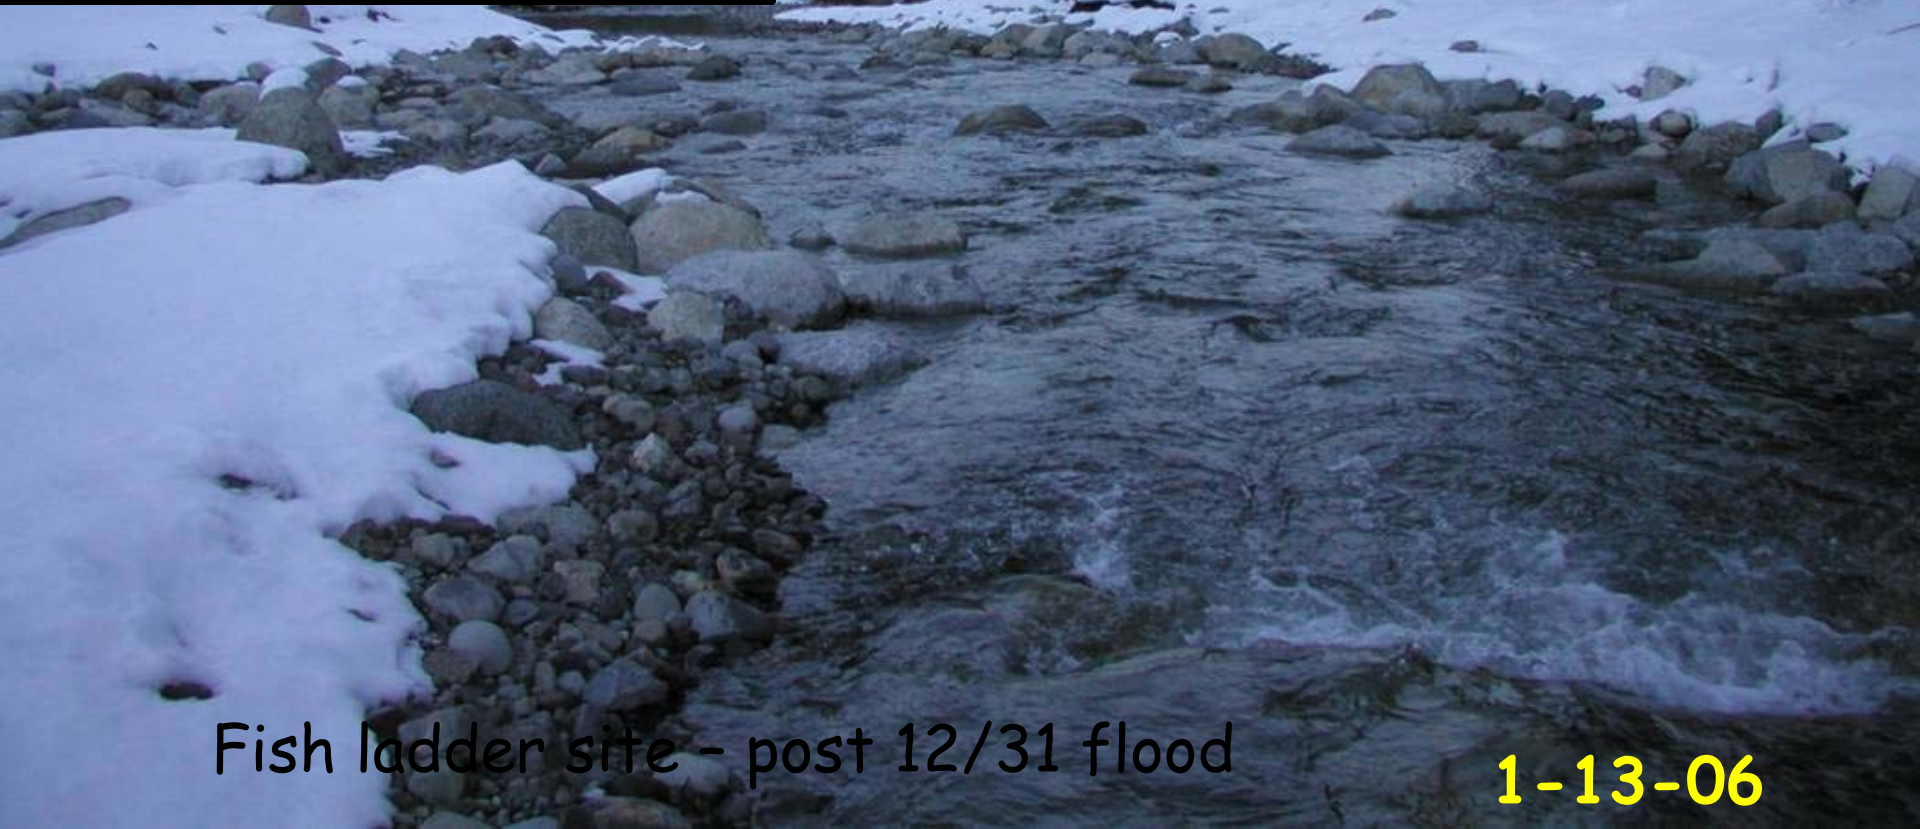
1-13-06

Fish ladder site - post 12/31 flood

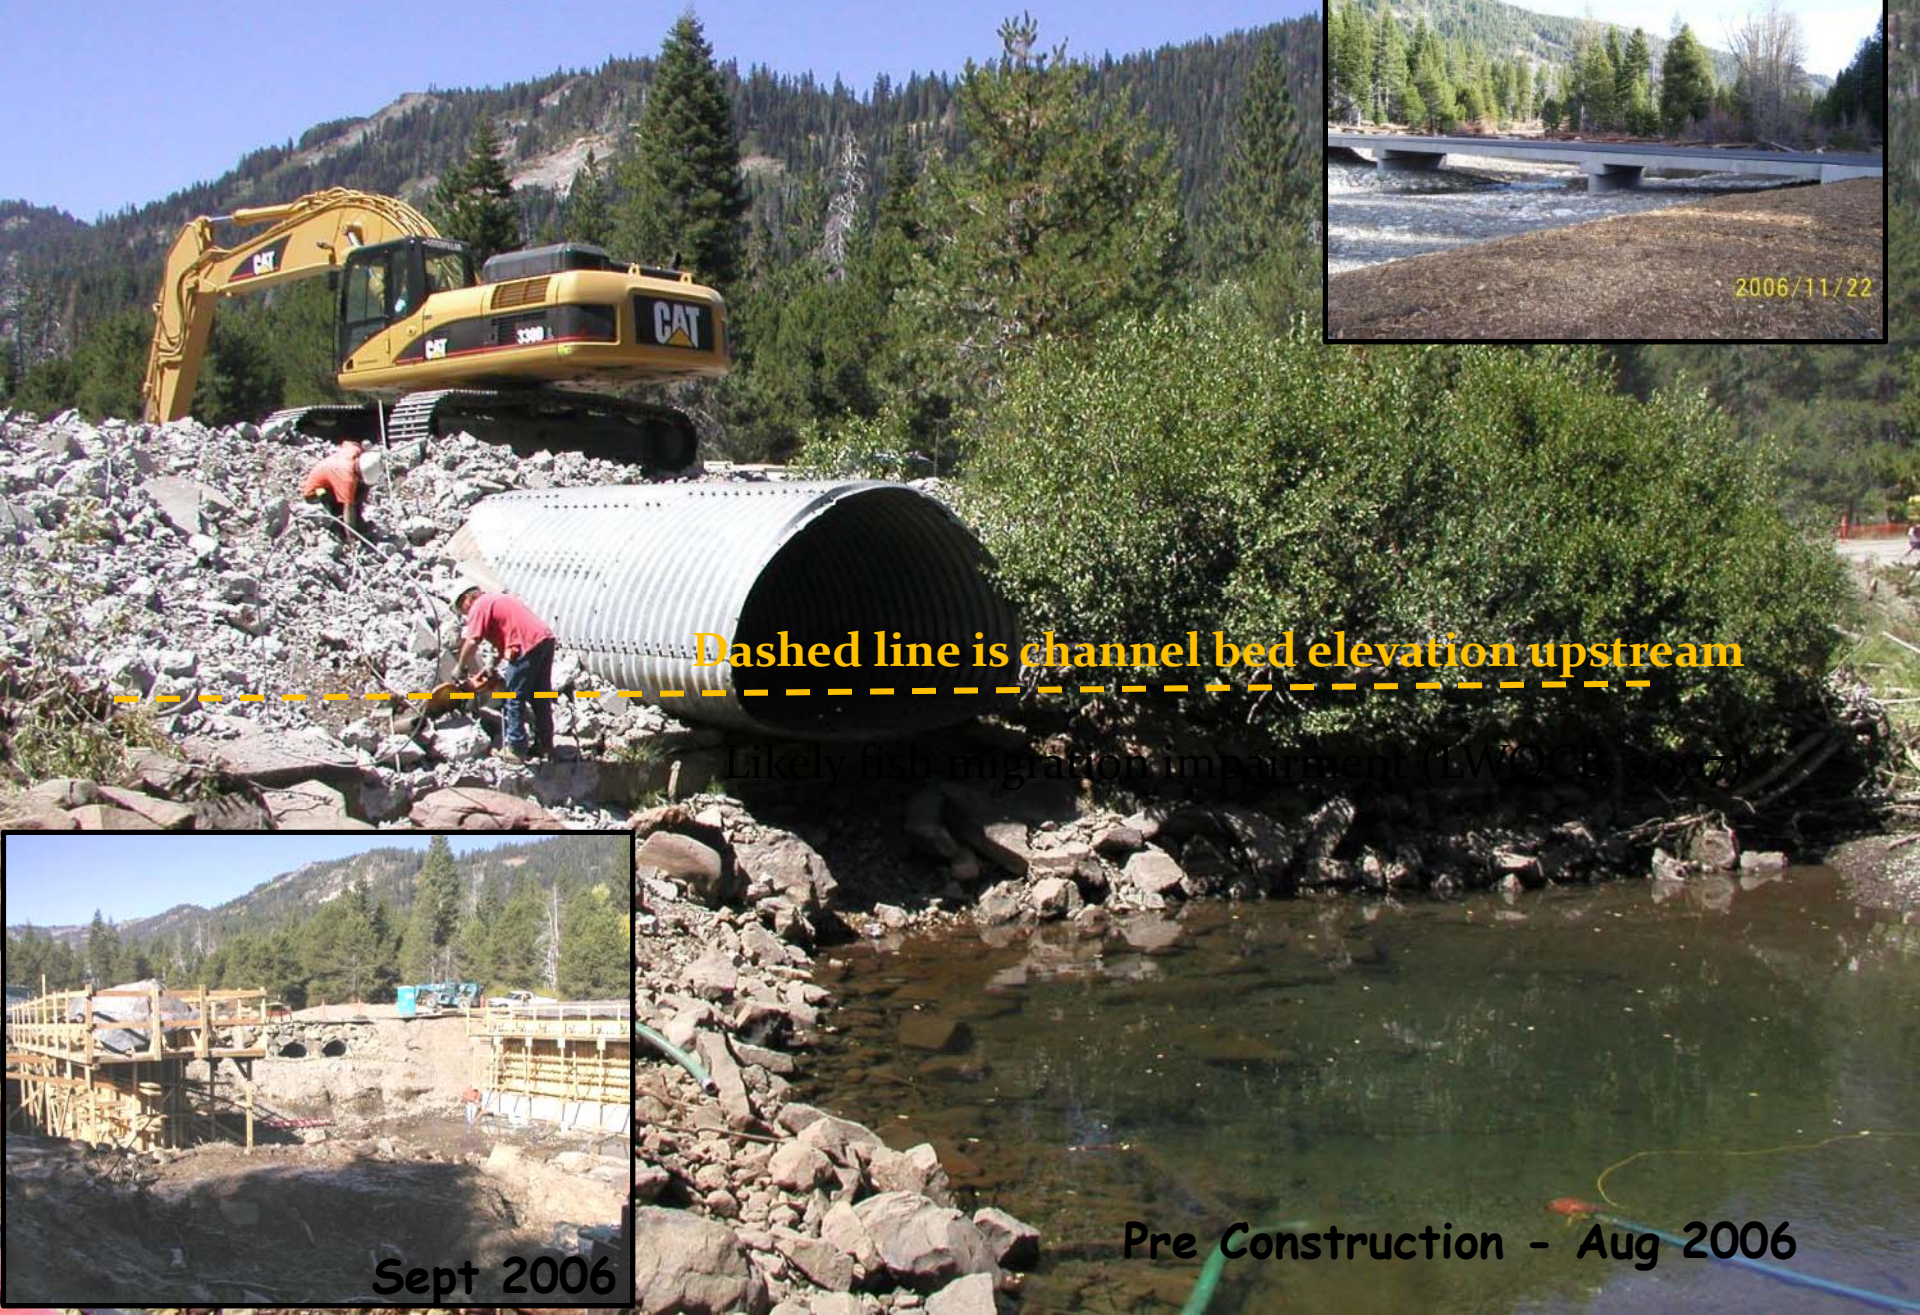
Dashed line is channel bed elevation upstream

Likely fish migration impairment (LWO)
