Effectiveness of Aquatic Invasive Plant Control in Emerald Bay, Lake Tahoe, California

Dan Shaw (CA State Parks)*, Zach Hymanson (Tahoe Science Consortium), Kim Boyd (Tahoe Resource Conservation District), Tamara Sasaki (CA State Parks)

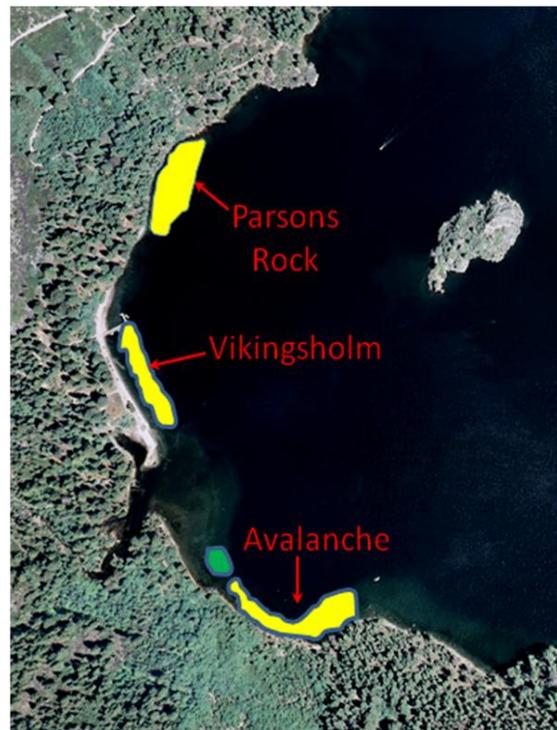
Figure 3. Delineation of approximate EWM infestation areas in fall, 2009.

By the end of 2009 three separate patches of EWM were established at the western end of Emerald Bay, covering a combined area of nearly 3 acres (Figure 3). In 2010 we pursued a combination of treatment methods over a larger proportion of one infestation site in a strategic attempt to attain control and eventually complete removal of a discrete infestation area. This paper describes the 2010 project and initial results.

surface area of approximately 704 acres). Three distinct areas infested with EWM were present in the western end of Emerald Bay in 2010 (Figure 3), covering approximately 3 acres.

In 2010, our efforts were focused on a single, defined infestation: the Vikingsholm site (Figure 3). This site was chosen because: (1) it was deemed the highest risk of spread to other areas due to boat traffic; (2) it has a gradual slope and sparse logs and rocks on the lake bed making it conducive to benthic barrier placement; and (3) the location allowed use of personnel on shore to help with abatement operations thereby reduce diving time. We used a combination of both benthic barrier and diver-assisted suction removal methods and we attempted to treat the entire infestation. Diver-assisted suction removal was strategically conducted at two intervals: (1) following the installation of the barriers; and (2) following the removal of the barriers. During these intervals, three priorities for diver-assisted suction removal were identified: (1) remove as much EWM as possible from around Vikingsholm Pier, because this is the area of highest risk of spread; (2) remove EWM plants from around and between benthic barriers if present; and (3) work from the southern extent of the infestation towards the north to get as complete and continuous EWM removal as possible given available time and money.
