Channel capacity and over-banking

Angora Creek and Washoe Meadows Enhancement

Project Phase IV Sewer Meadow Reach

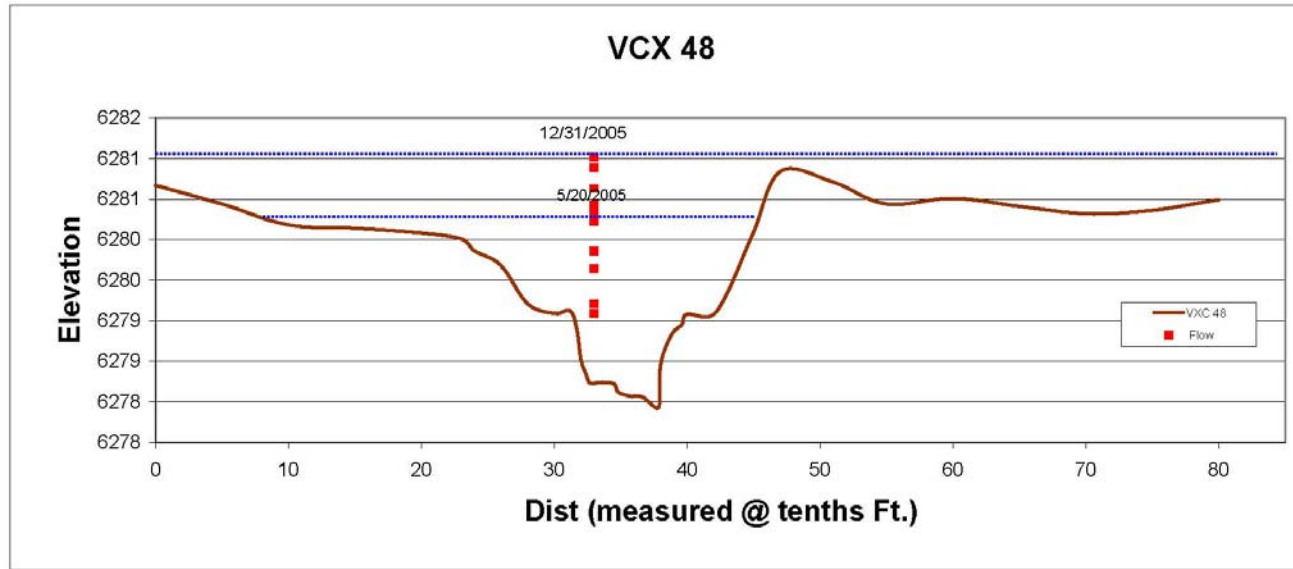
Pin flag flow
elevation and
note time

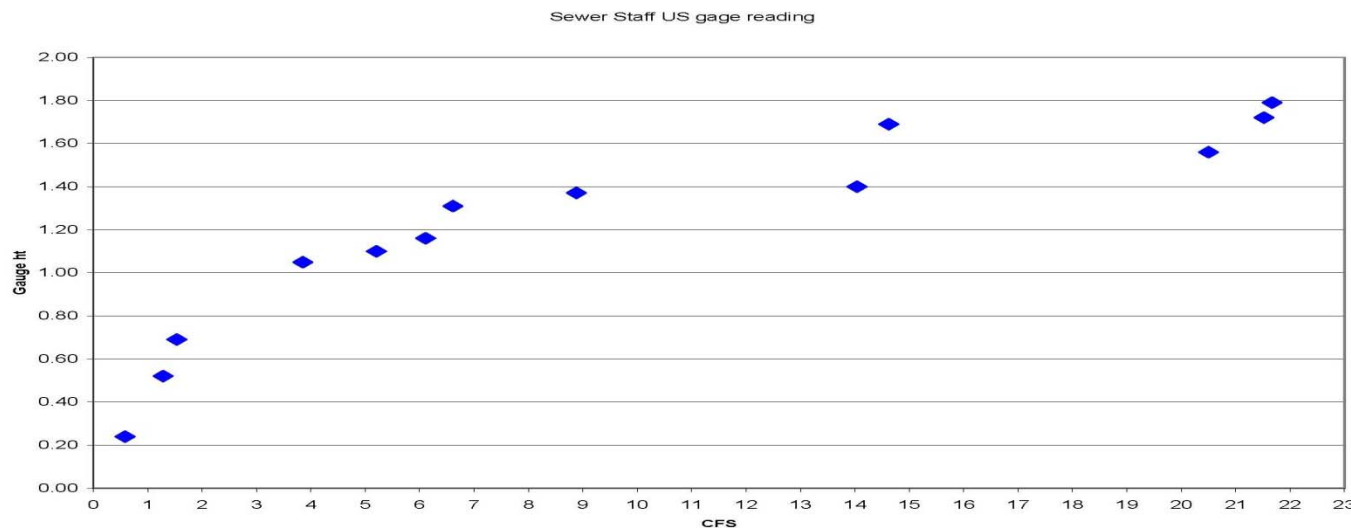
Rating curve
Flow
measurements
taken at staff gage
and recorder

Gauge records stream stage

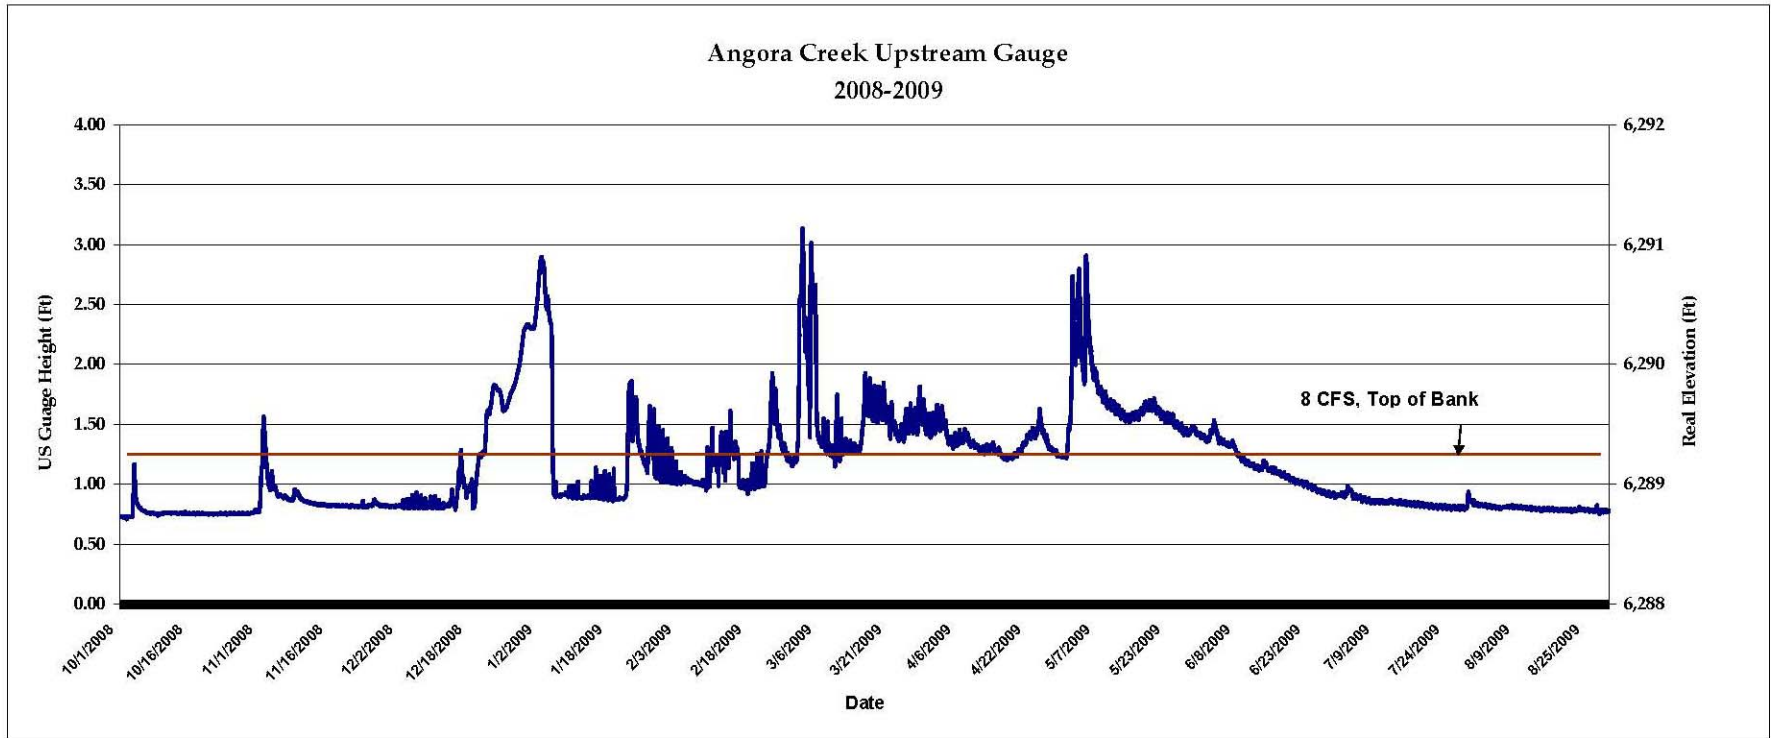
Duration: Post-project shows stream is out of bank approximately 90 days in the 08-09 water year
Pre project channel was approximately 1 to 2 feet deeper and had 2 to 4 times the capacity. It was rarely out of bank—only large flood events

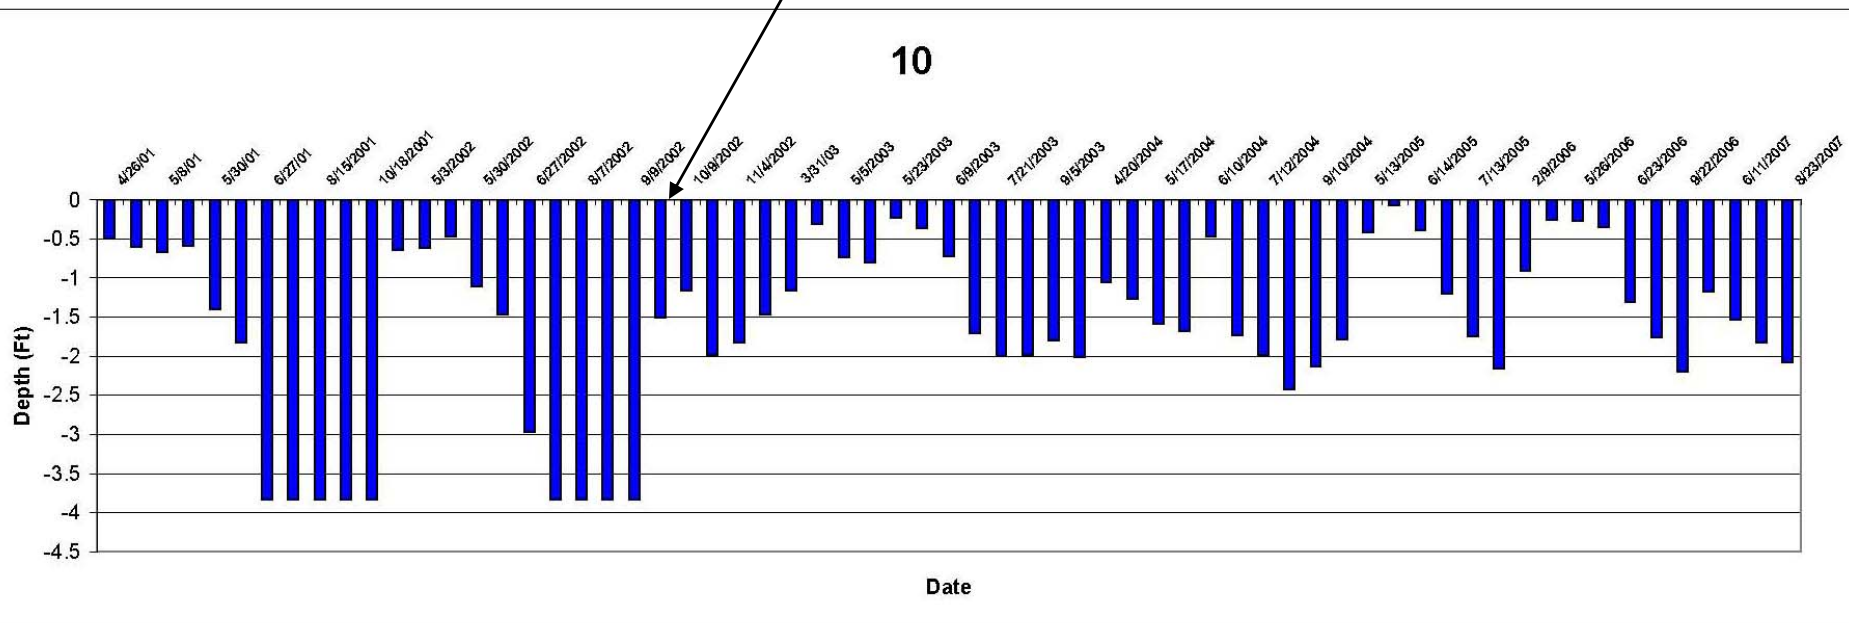
Groundwater wells

Depth to water changes dramatically

Water within root zone post-project

Pre-project wells dry (water >4') from late June thru fall to following spring

Water released into new channel

Post-project wells show water within 1-2 feet of surface within growing season (late June thru Sept)

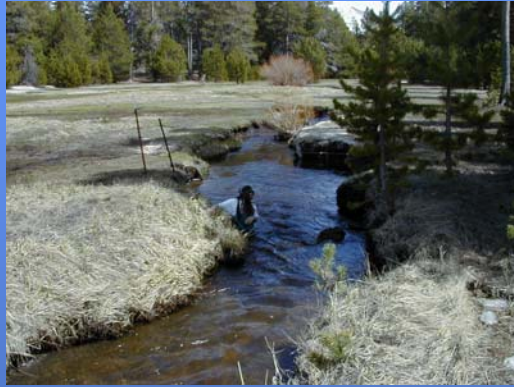
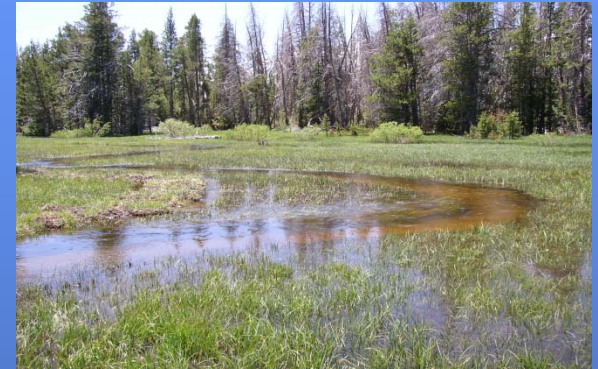
Relation of groundwater to cross section

Pre-restoration channel:

- incised and widened
- capacity 30 cfs
- groundwater 2-4' below surface
- water not available to plants

Post-restoration channel

- smaller channel connected to meadow
- capacity 8cfs
- groundwater at or near surface
- restored channel has more water available to plants

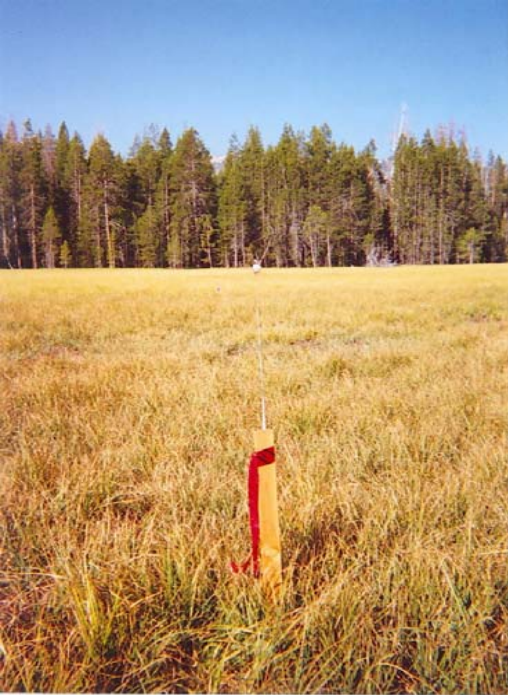
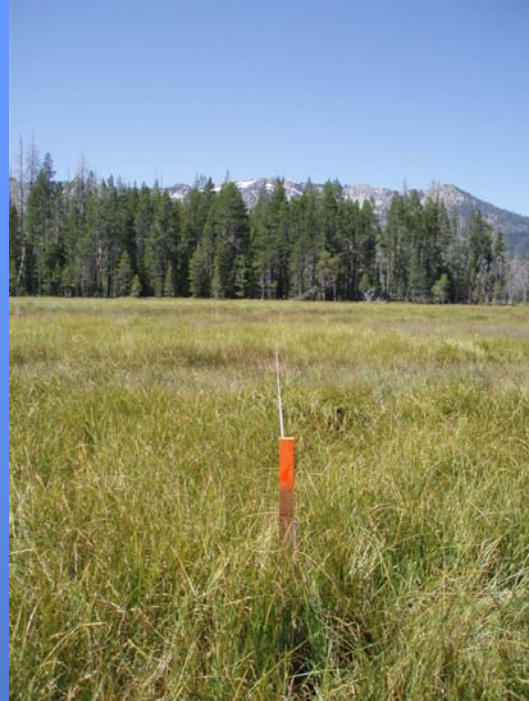
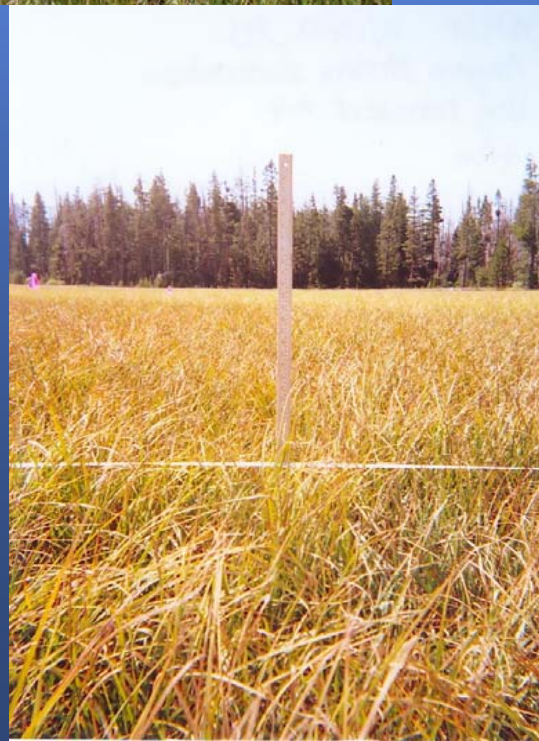
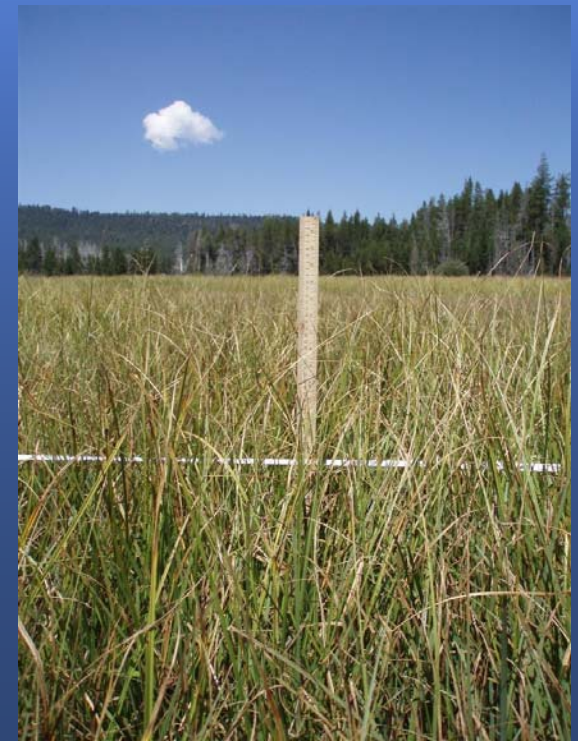
Vegetation photo points August 2000 and 2006

pre-post photo pairs
