Blackwood Creek Project Implementation

*Geomorphic form restoration—Providing
the foundation to restore riparian
vegetation structure,
habitats, and aquatic life*

Craig Oehrli – Hydrologist
Lake Tahoe Basin Mgt Unit
Forest Service

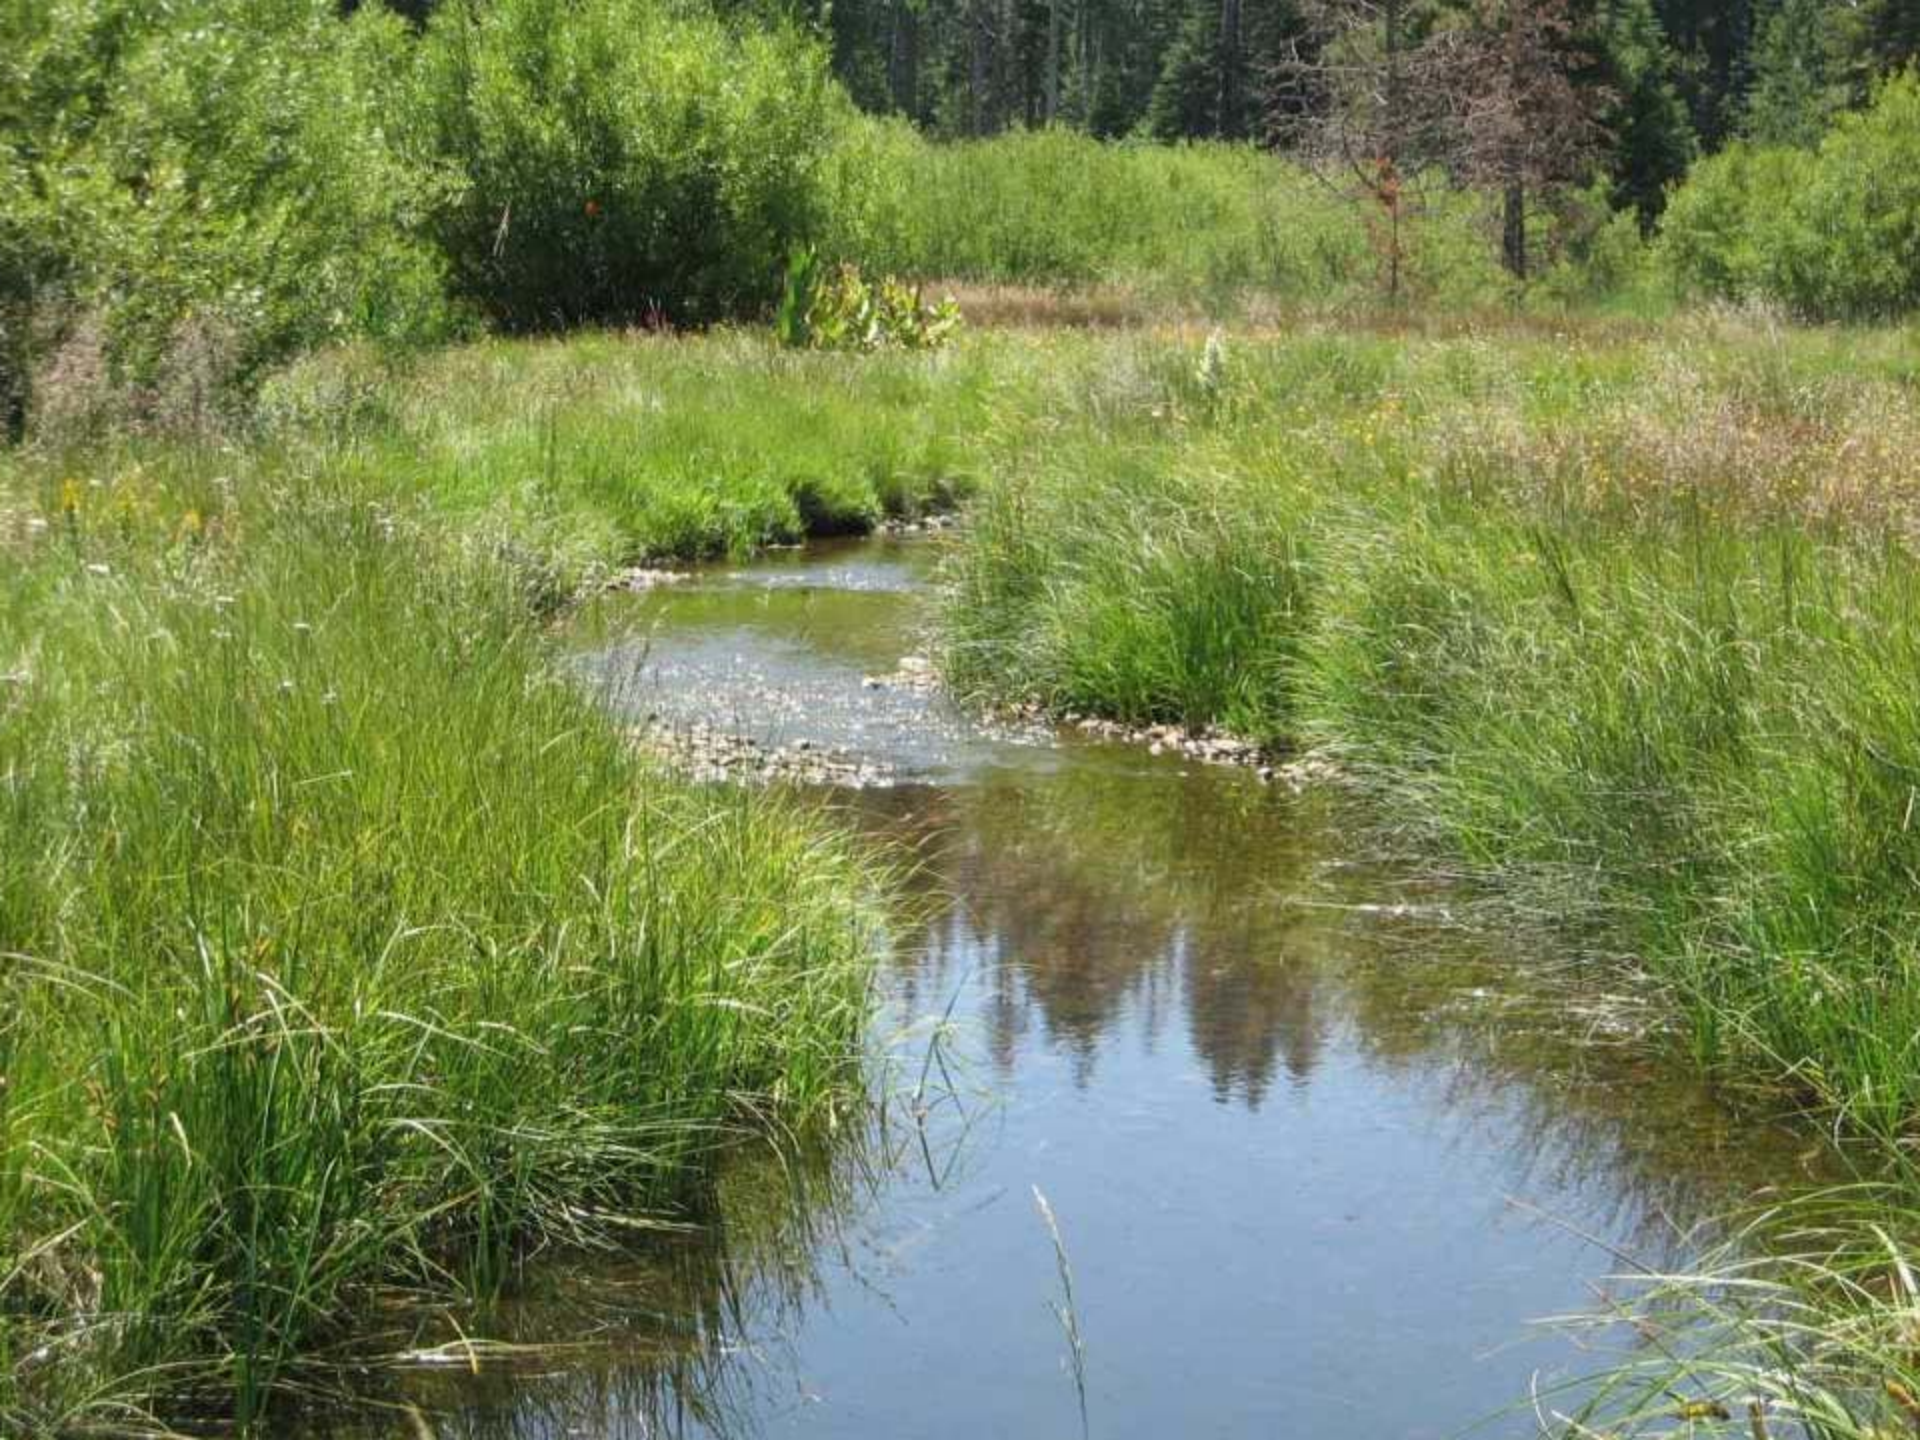
Indicator: modified Greenline method, measures percent cover of live sod, and percent of live willow stakes and mats.

Result: In spring 2007, 85% sod cover, 100% sprouting willow stakes, 91% willow mats (in 2006).

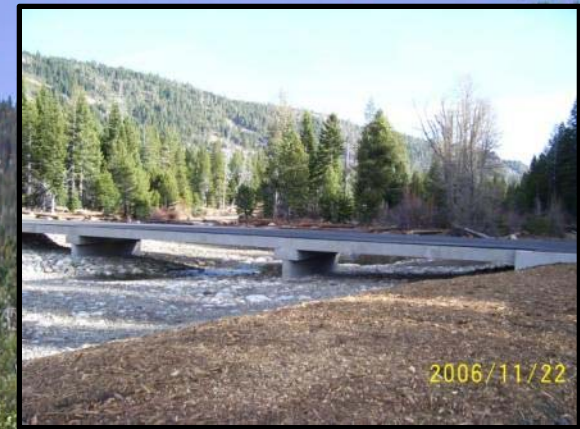
Phase II

Dashed line is channel bed elevation upstream

Likely fish migration impairment (LWO)
