USFS Stream Channel/Floodplain Restoration Project Effectiveness Monitoring

- Big Meadow Creek/Cookhouse Meadow Restoration – Completed 2006
- Blackwood Creek Phase I – Fish Ladder Removal- Completed 2003
- Blackwood Creek Phase II- Bridge Replacement- Completed 2006
- Blackwood Creek Phase IIIA- Stream Channel/Floodplain Reconstruction – Completed 2009

Big Meadow Creek /Cookhouse Meadow

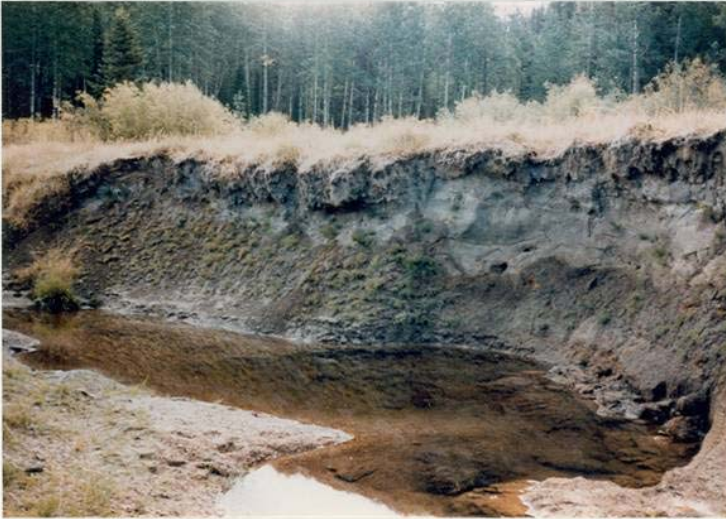
1981

The Problem : Big Meadow Creek in Cookhouse Meadow

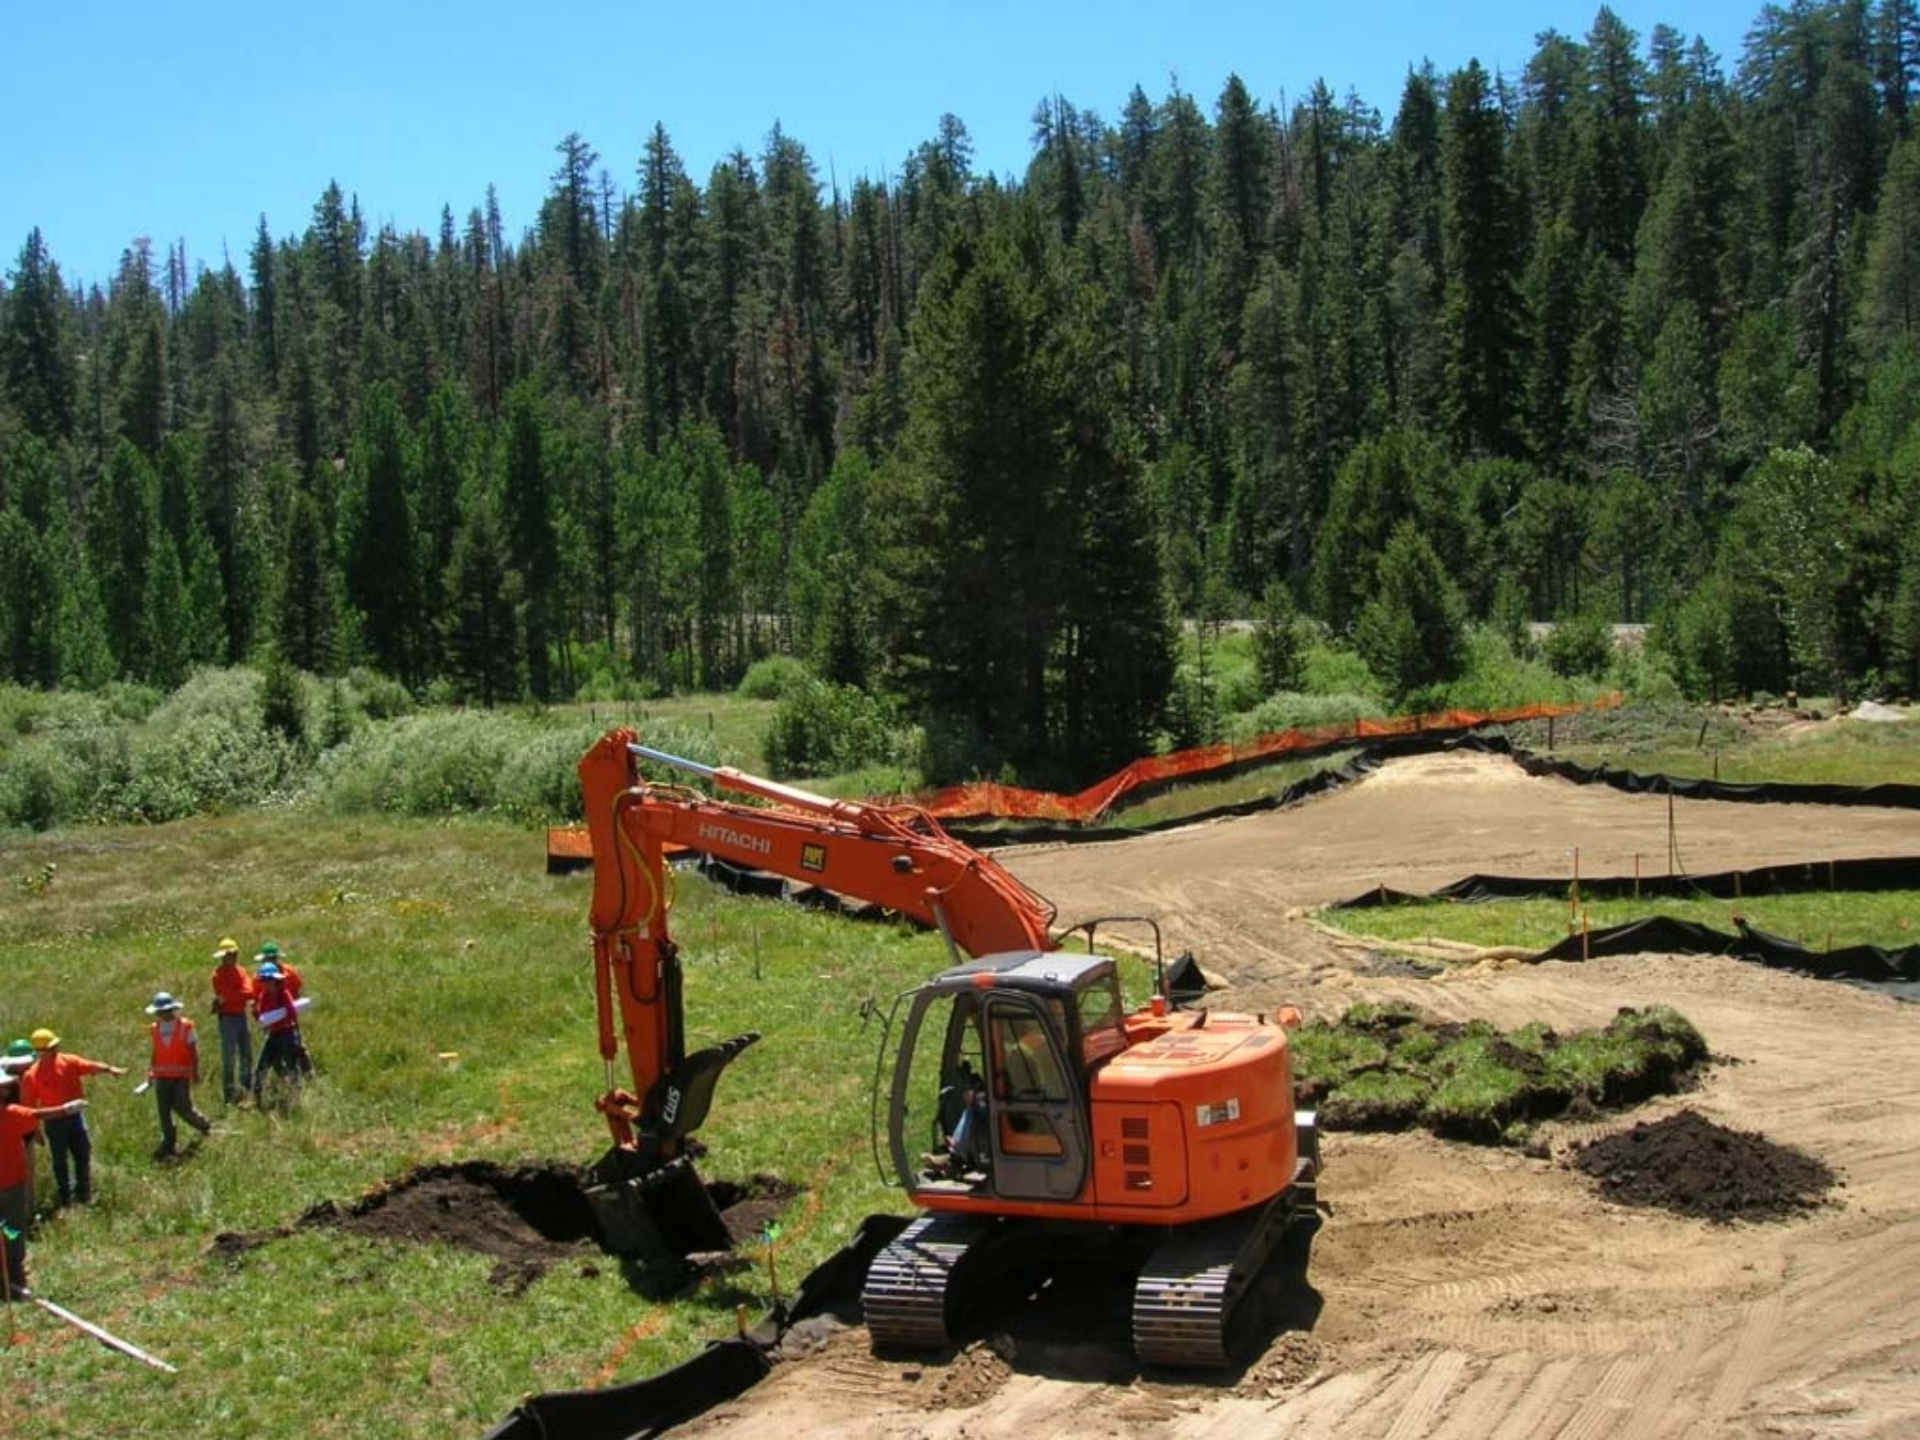
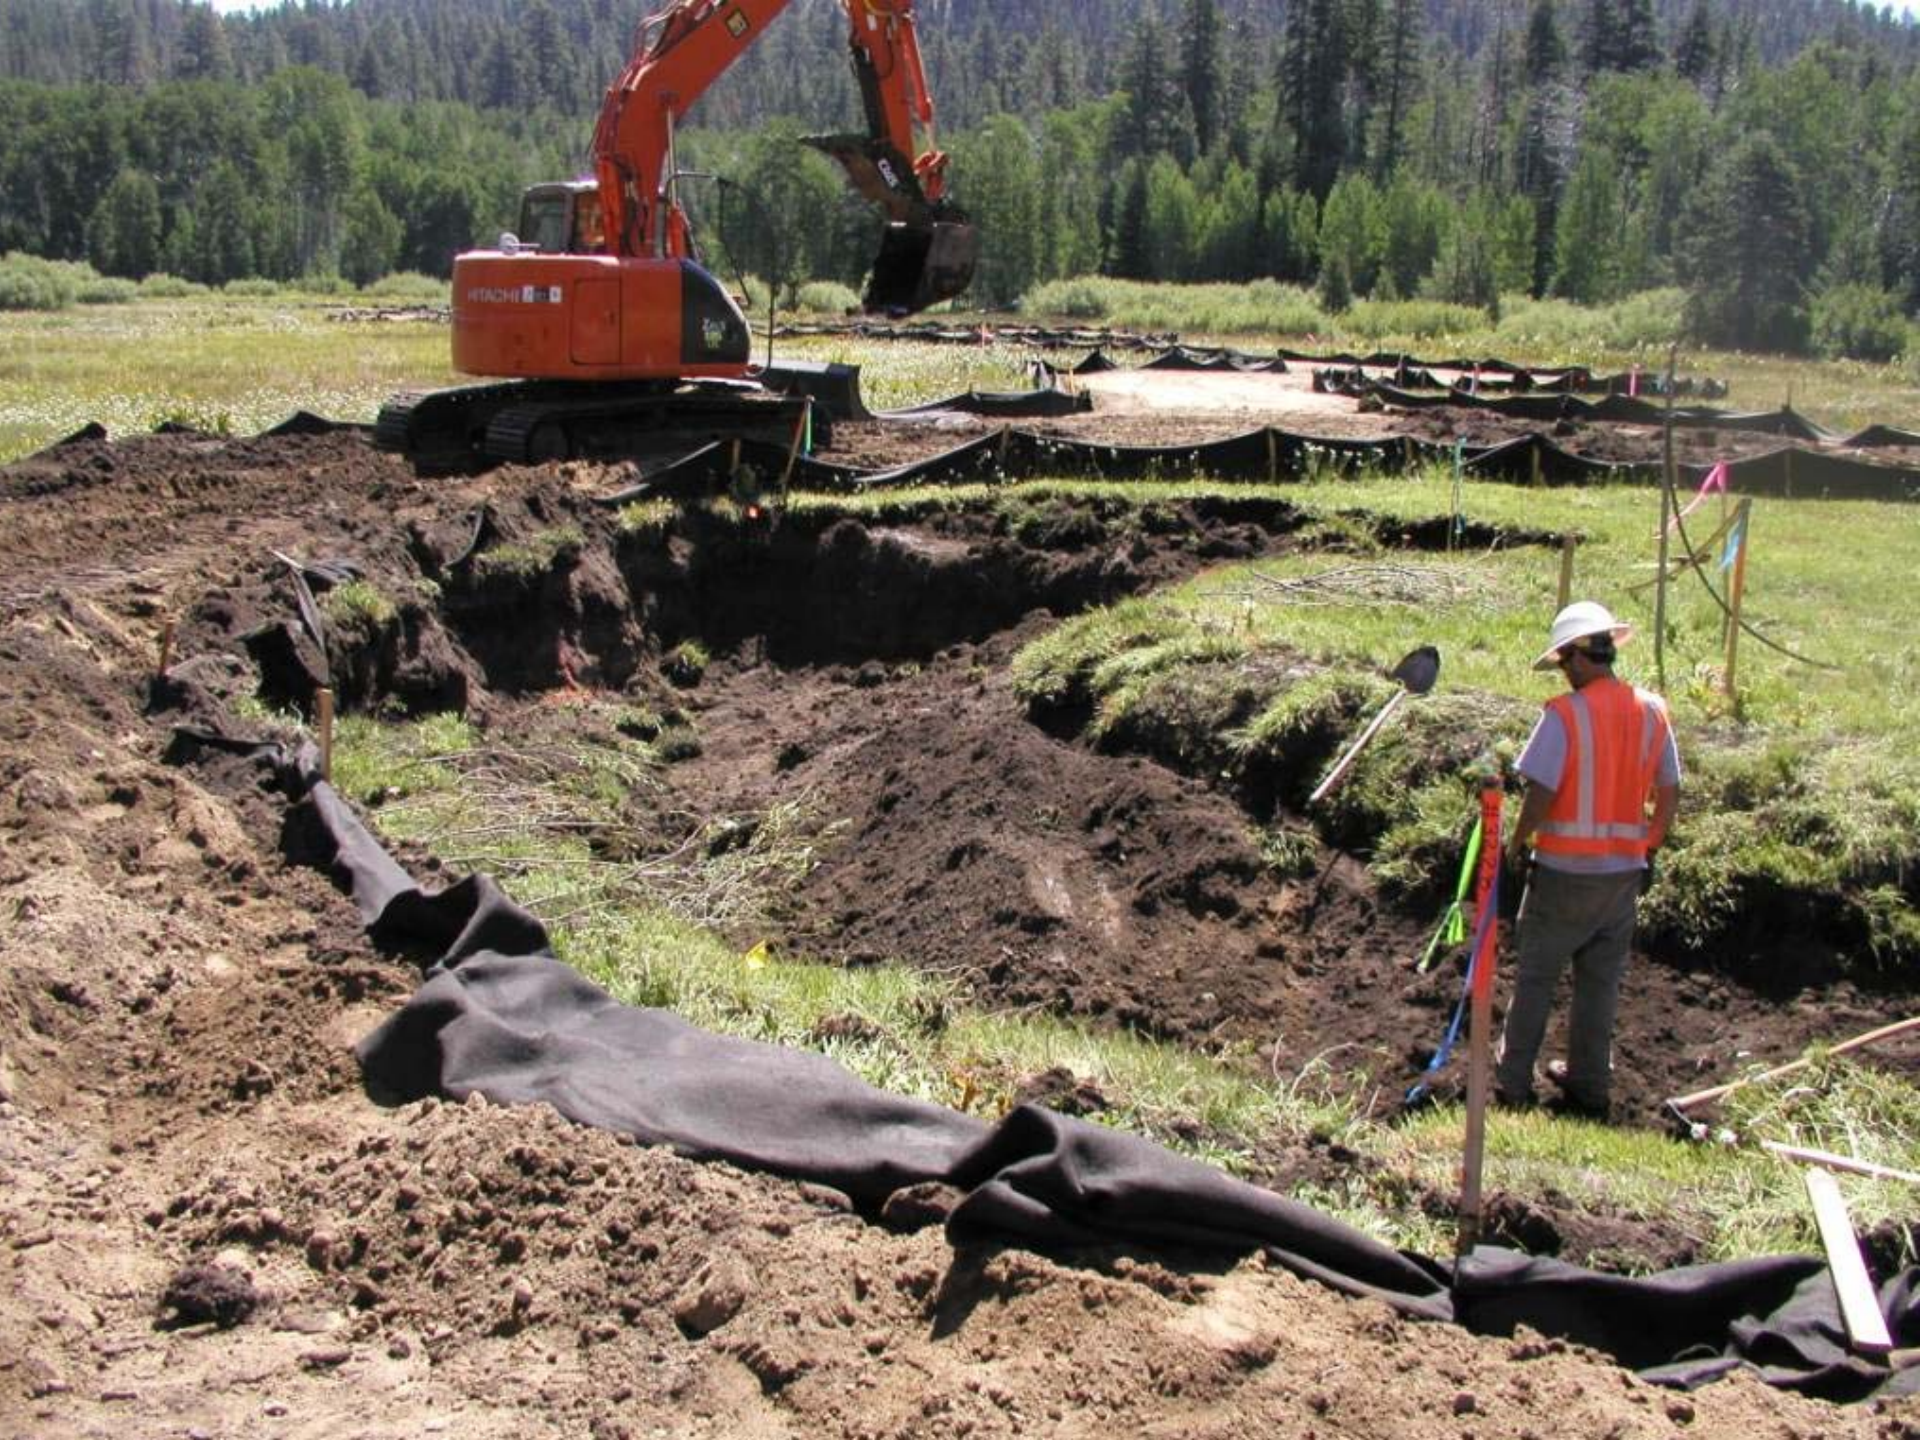
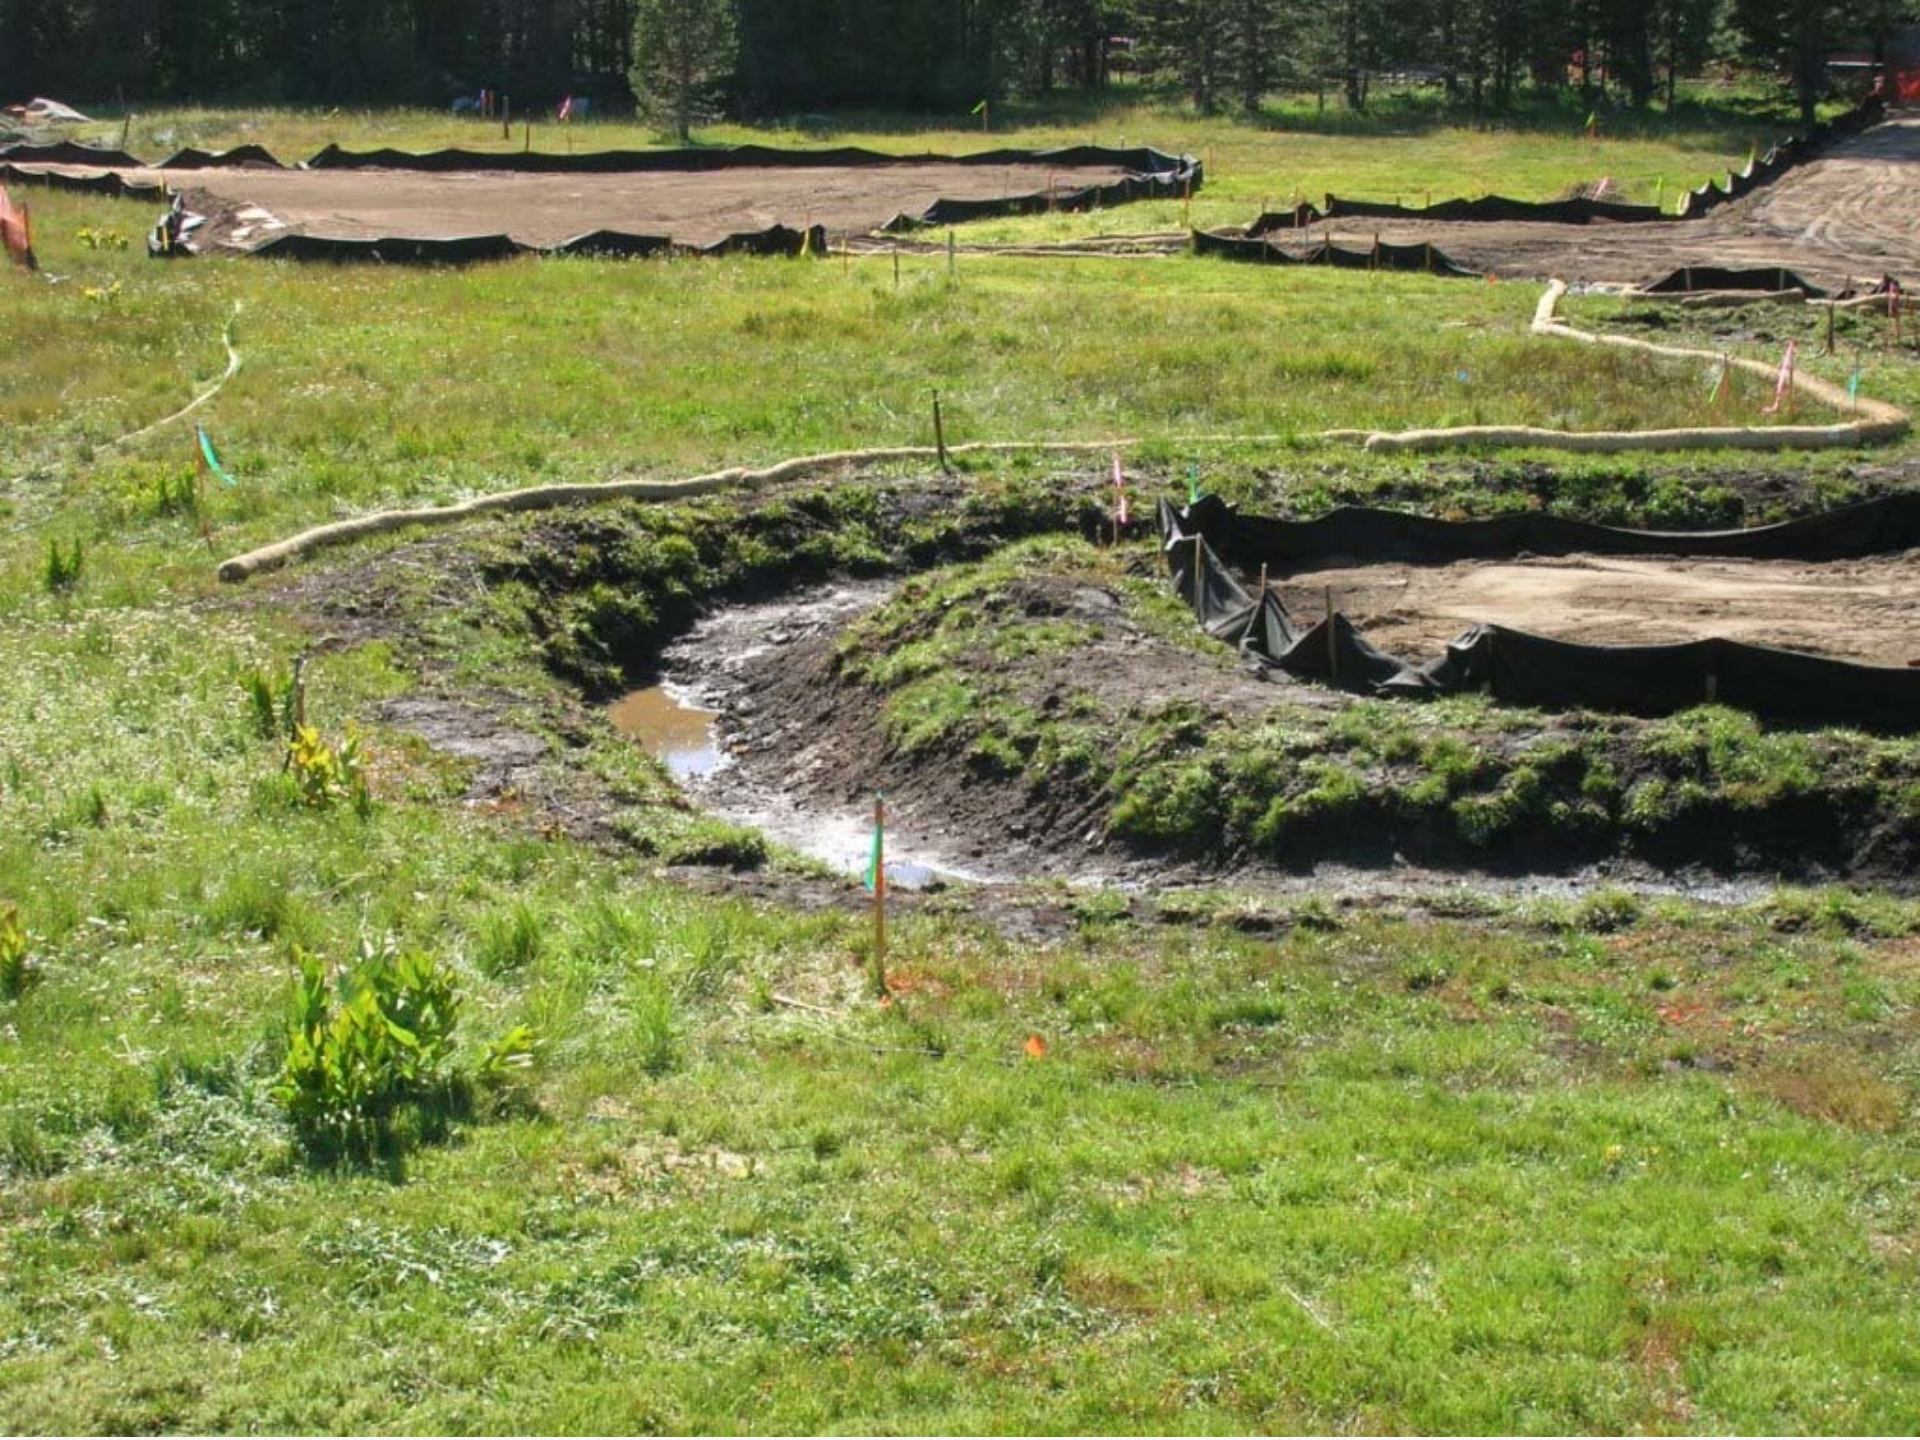
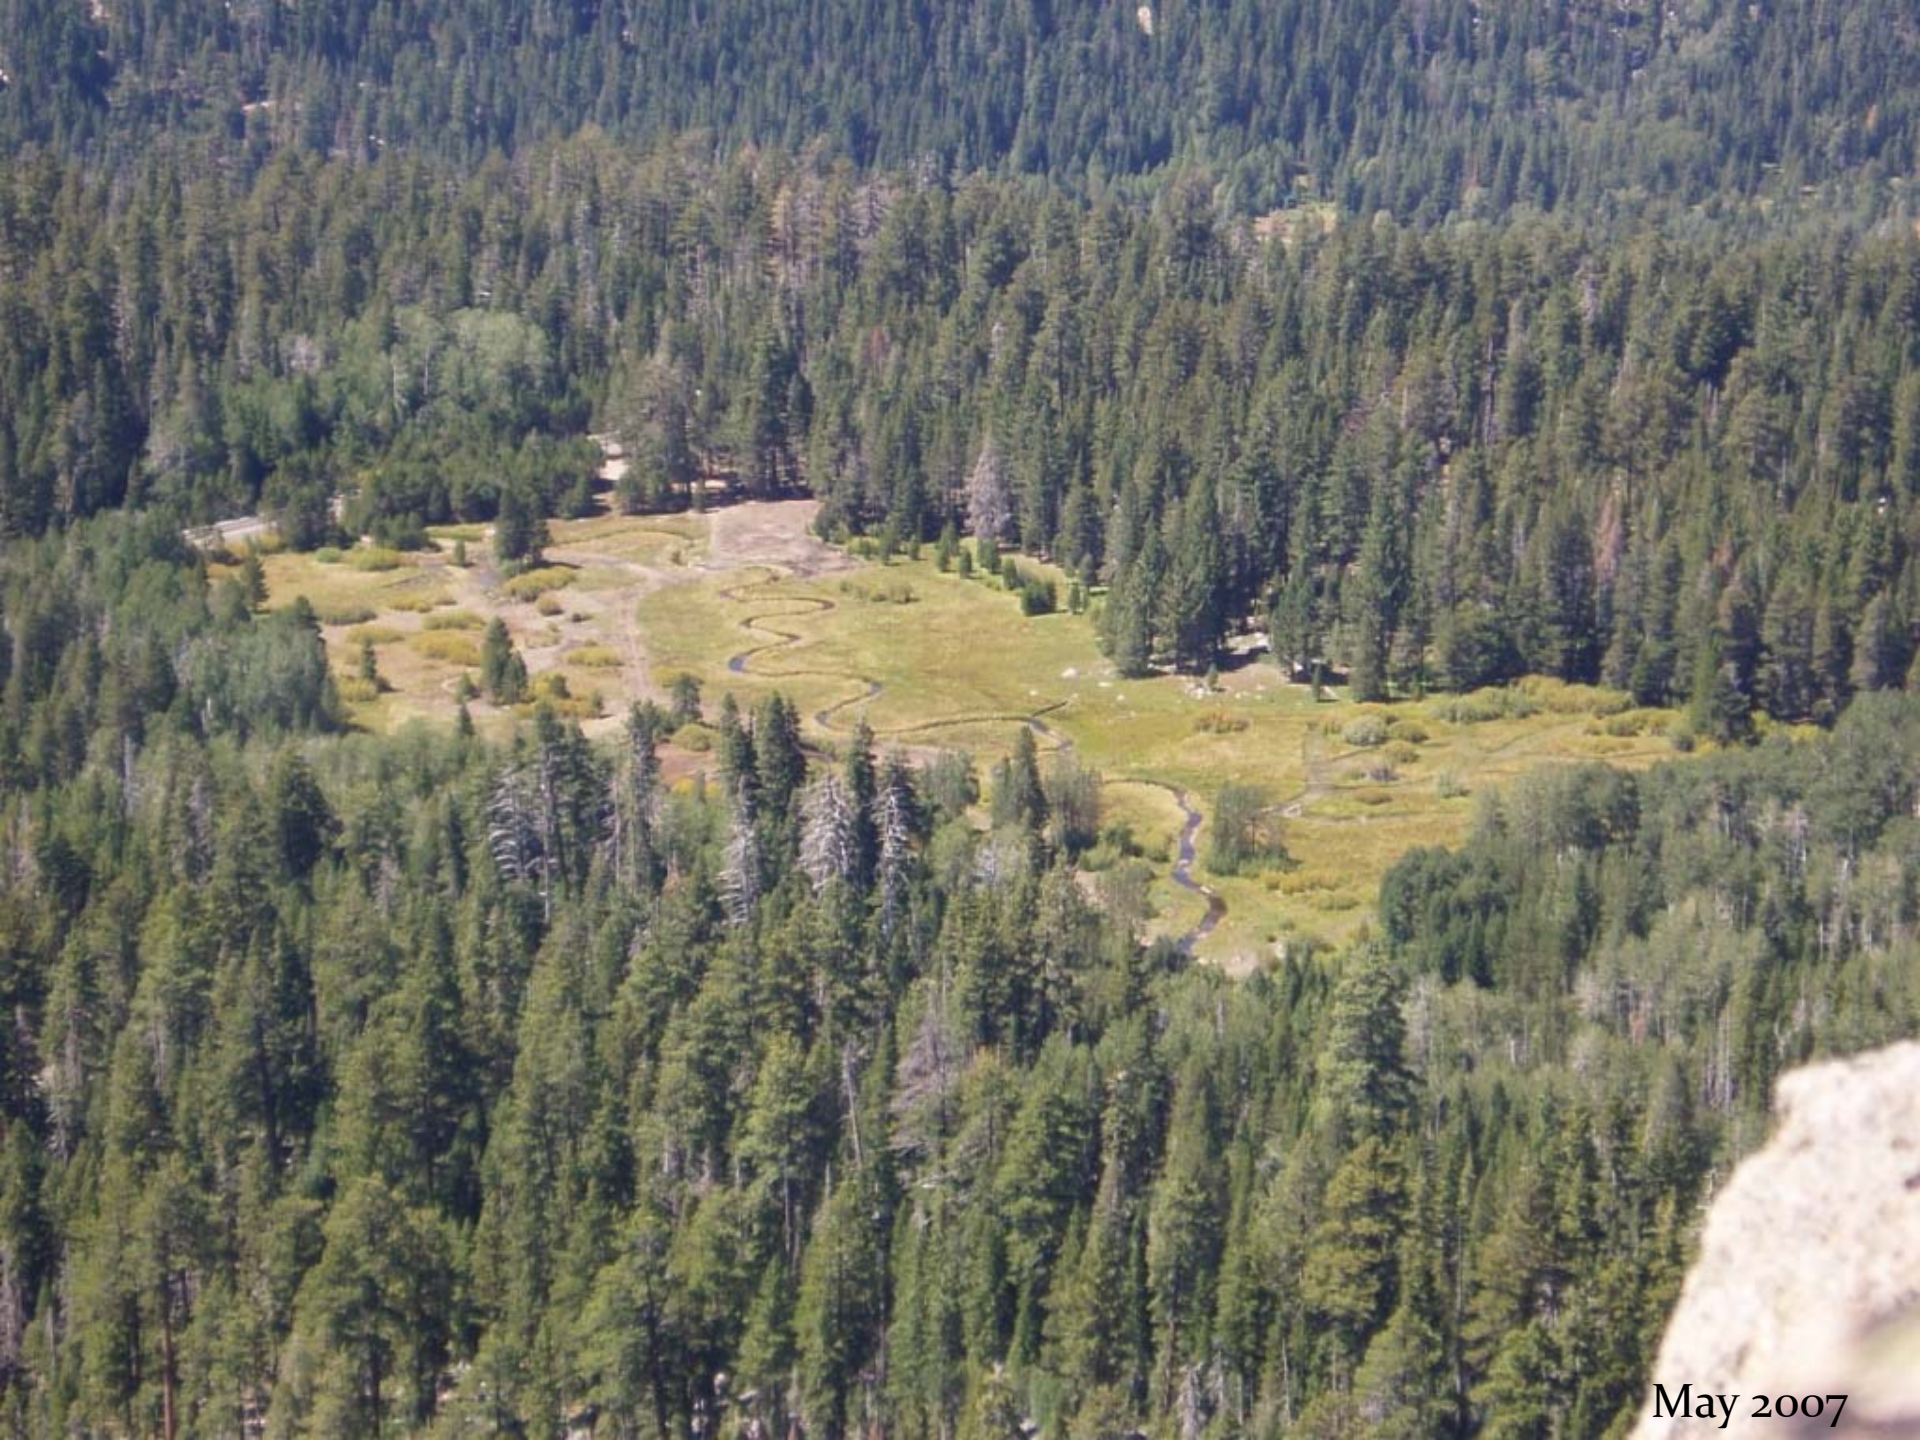
May 2007

- Construction of 2,400 feet of new C4 channel. Raised elevation of the stream channel by approximately 6 to 10 feet, so that riffle elevation is 1 to 1.5 feet from the top of bank.
- Plug and partial fill of 1,400 of old channel
- Harvest meadow sod, placed on newly constructed channel banks and used as plugs in filled areas
- Placement of willow wattles, willow mats, and willow stakes within floodplain and channel banks.
